# Manhole Inspection Summary

Manhole # S41A\_\_001MH

**Location** Address: **N CENTRAL AVE**

Cross Street: **ORLEANS ST**

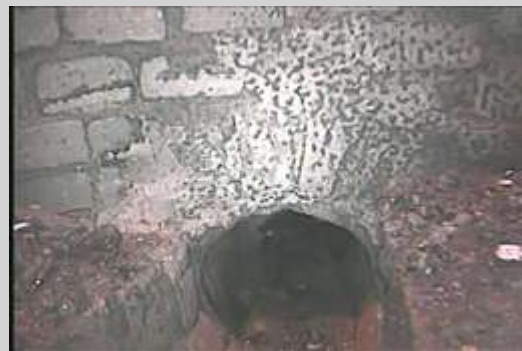
Drop In @ 3 O'Clock

Drop: **Inside** Rod and Bar  
Angled: **Yes** Reading: **14.40** (ft.)  
Inv Depth: **15.40** (ft.)  
Drop Condition: **Open**

Connects To: **House connection / Service line**

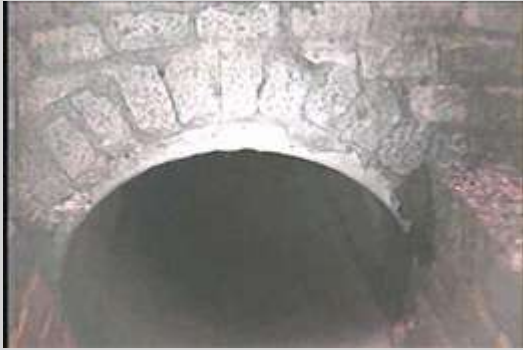
6 O'Clock Inflow

24 in. Circular Gravity Sewer

Pipe In @ 6 O'Clock

Infiltration: **None** Pipe Seal Cond: **Sound**
